ATTACHMENT A

Photolog

Greenleaf Ledge Dairy, LLC
EPA Inspection May 9, 2019
All photos taken by Ben Atkinson, Agronomist, U.S. EPA
Camera: Ricoh WG-4 and Olympus

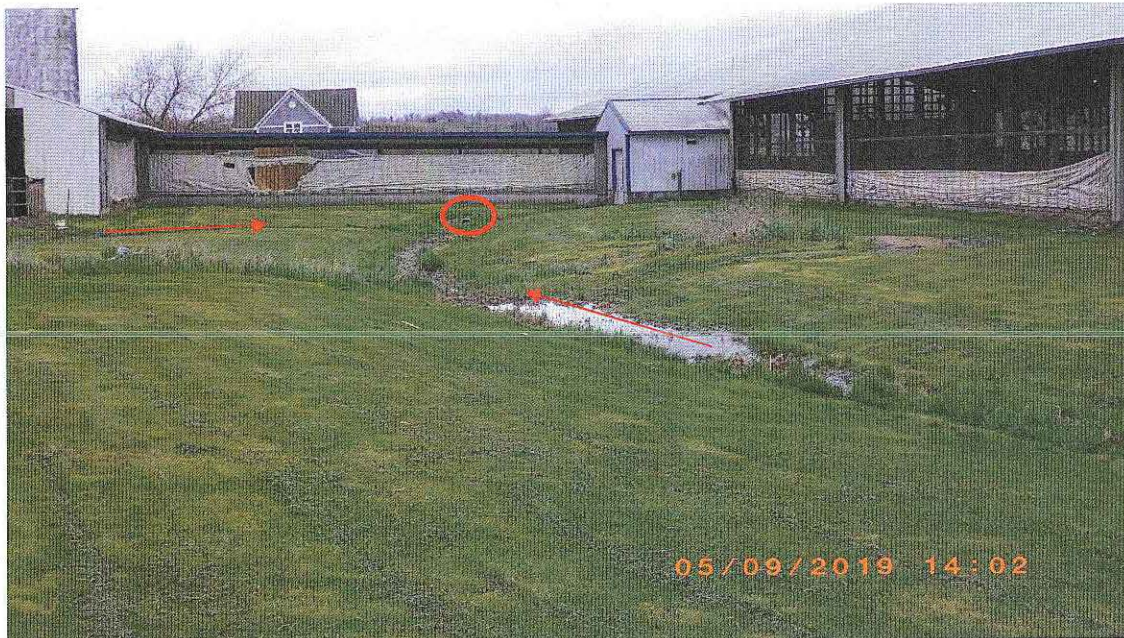
63: RIMG0113

Description: EPA observed stormwater mixed with used bedding flowing to the north and stormwater mixing with manure and feed from the open feed lot connected to the Heifer and Steer Barn flowing to the northeast. Both flow channels merge and flow through a culvert inlet that conveys flow under the cow walkway (red circle is the location of the culvert inlet).

Location: Southwest of the Milking and Dry Cow Barn and south of the Heifer and Steer Barn.

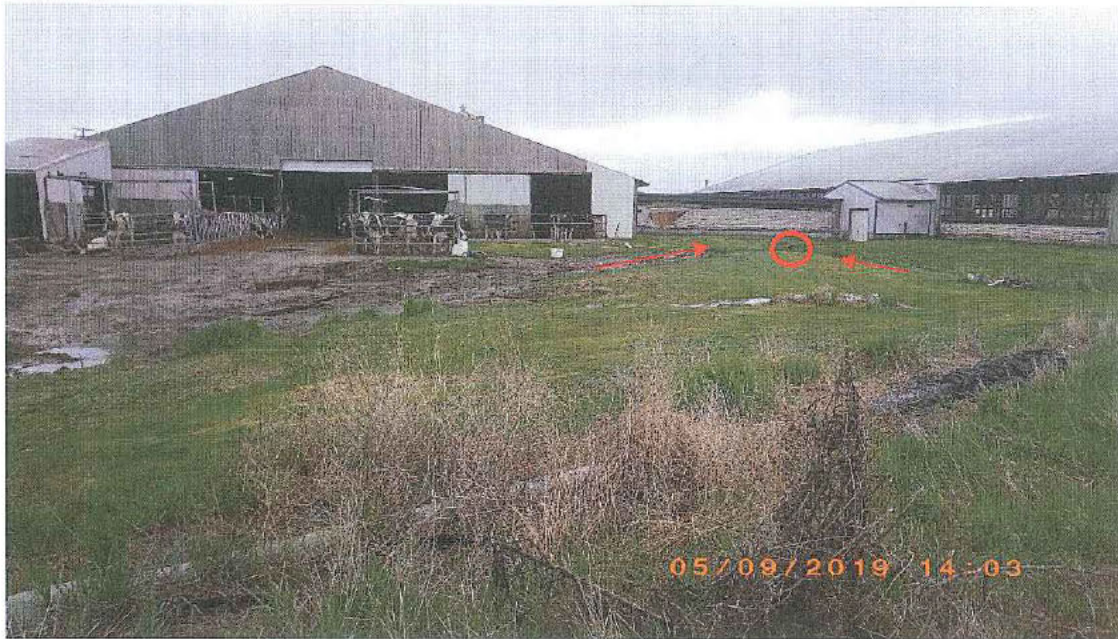
64: RIMG0114

Description: EPA observed stormwater mixed with used bedding flowing to the north and stormwater mixing with manure and feed in the open feed lot connected to the Heifer and Steer Barn to the northeast. Both flow channels merge and flow through the culvert inlet that conveys flow under the cow walkway (red circle is the location of the culvert inlet).

Location: South of the Heifer and Steer Barn

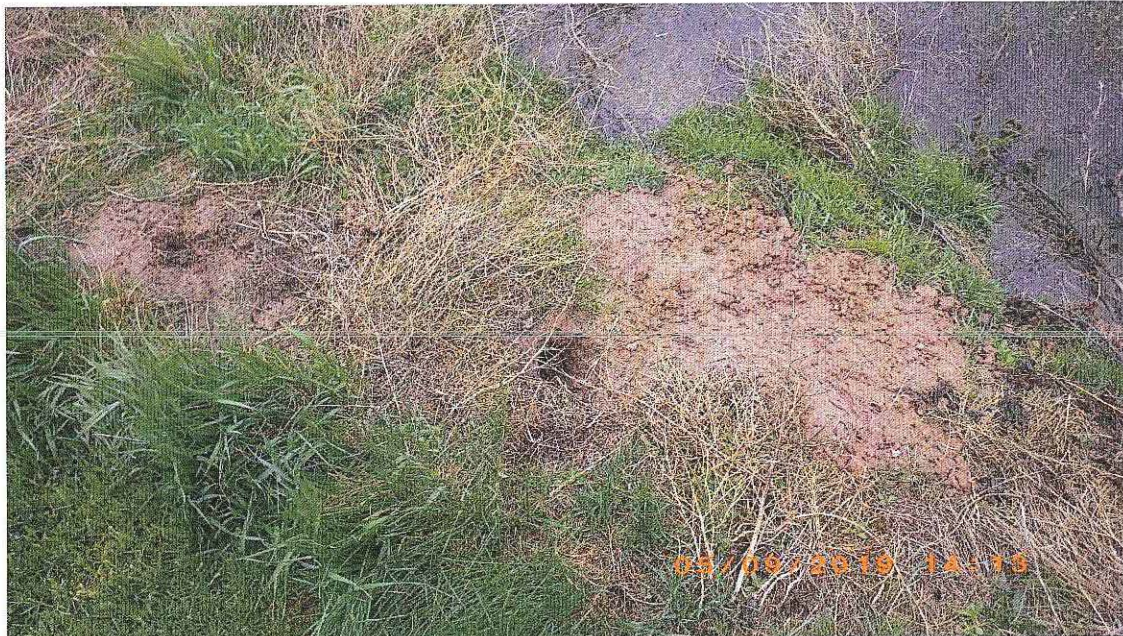
74: RIMG0124

Description: EPA observed rodent holes on the west berm of the New Pit.
